# Long-term performance and carbon emissions associated to tunneling

Tarcisio Celestino  
ITA President

Buenos Aires, 8 Sep. 2017

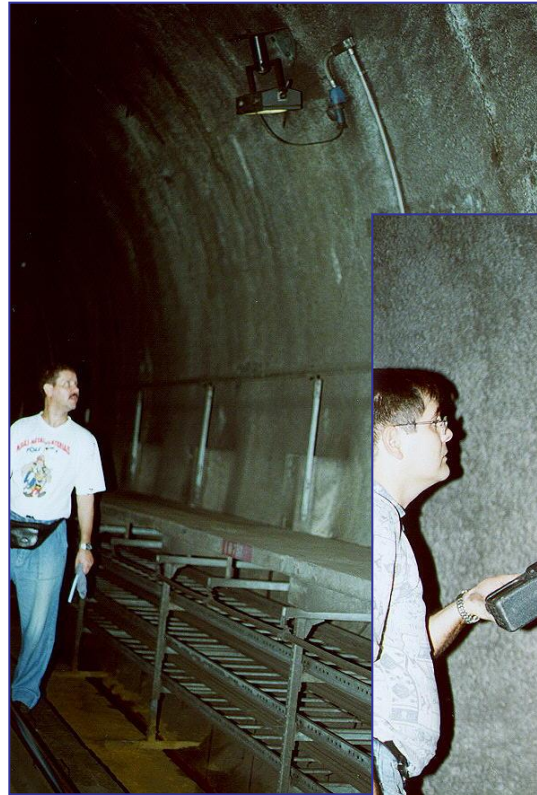
# Shotcrete lining for the São Paulo Subway

$t = 0.25 \text{ m}$   
 $p = 2 \text{ bar}$

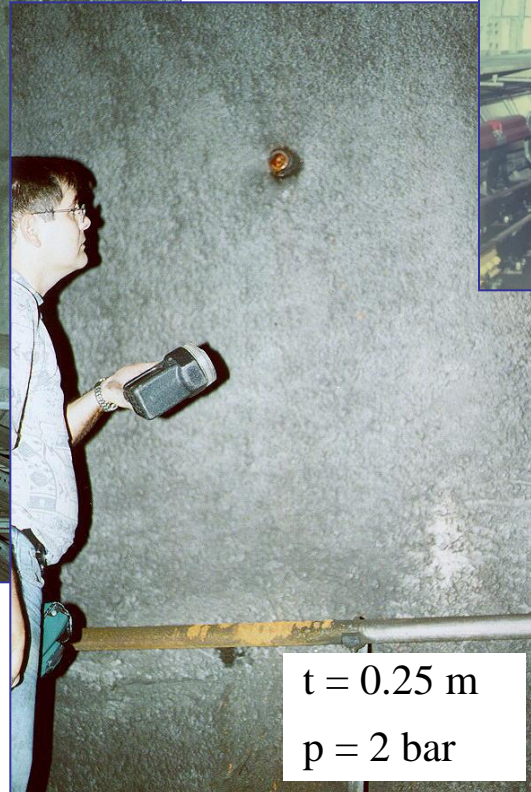
$t = 0.25 \text{ m}$   
 $p = 2 \text{ bar}$

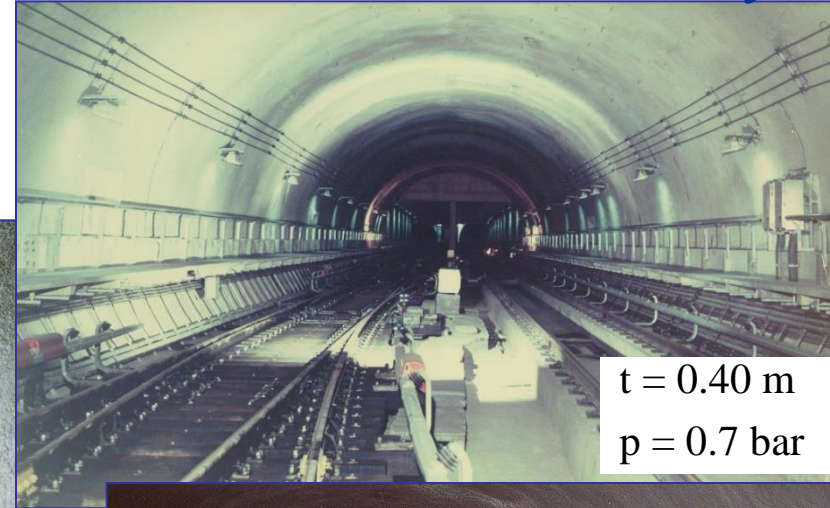
$t = 0.40 \text{ m}$   
 $p = 0.7 \text{ bar}$

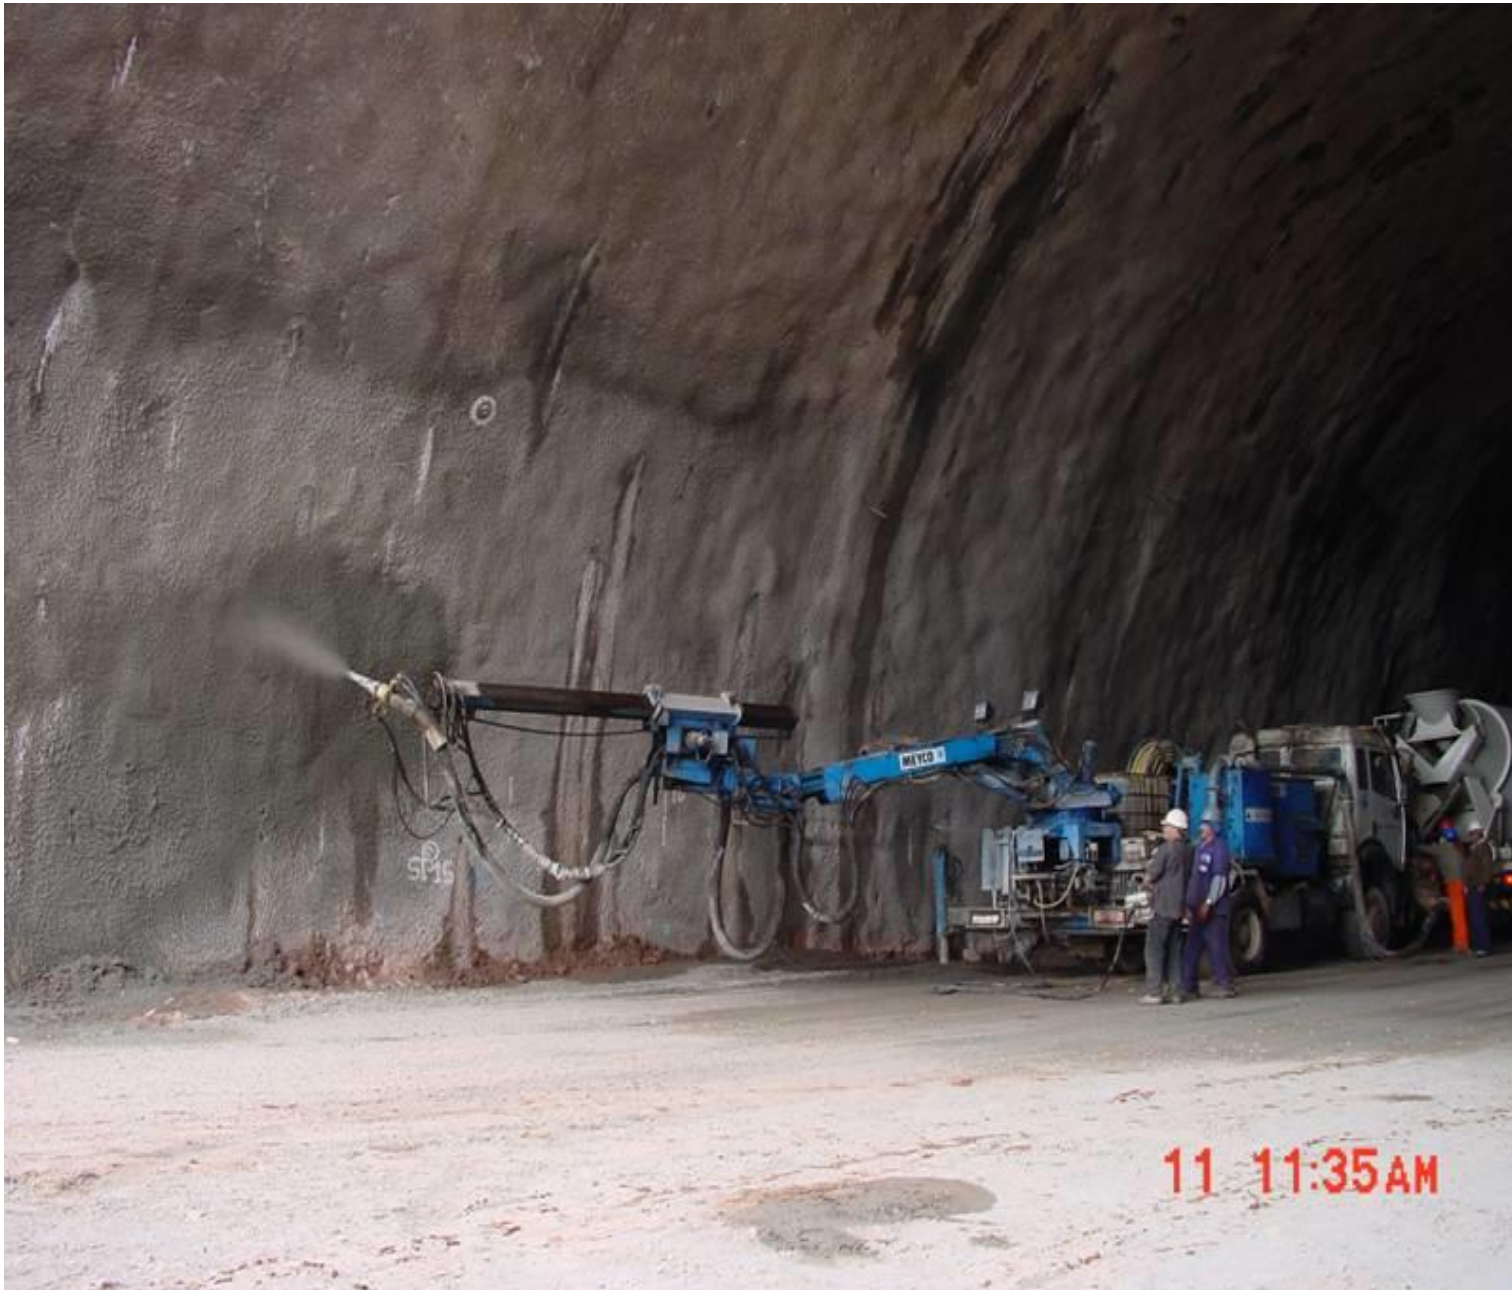
São Paulo Ring Road  
200 m<sup>2</sup>  
4 lanes 86,000 vehic/day

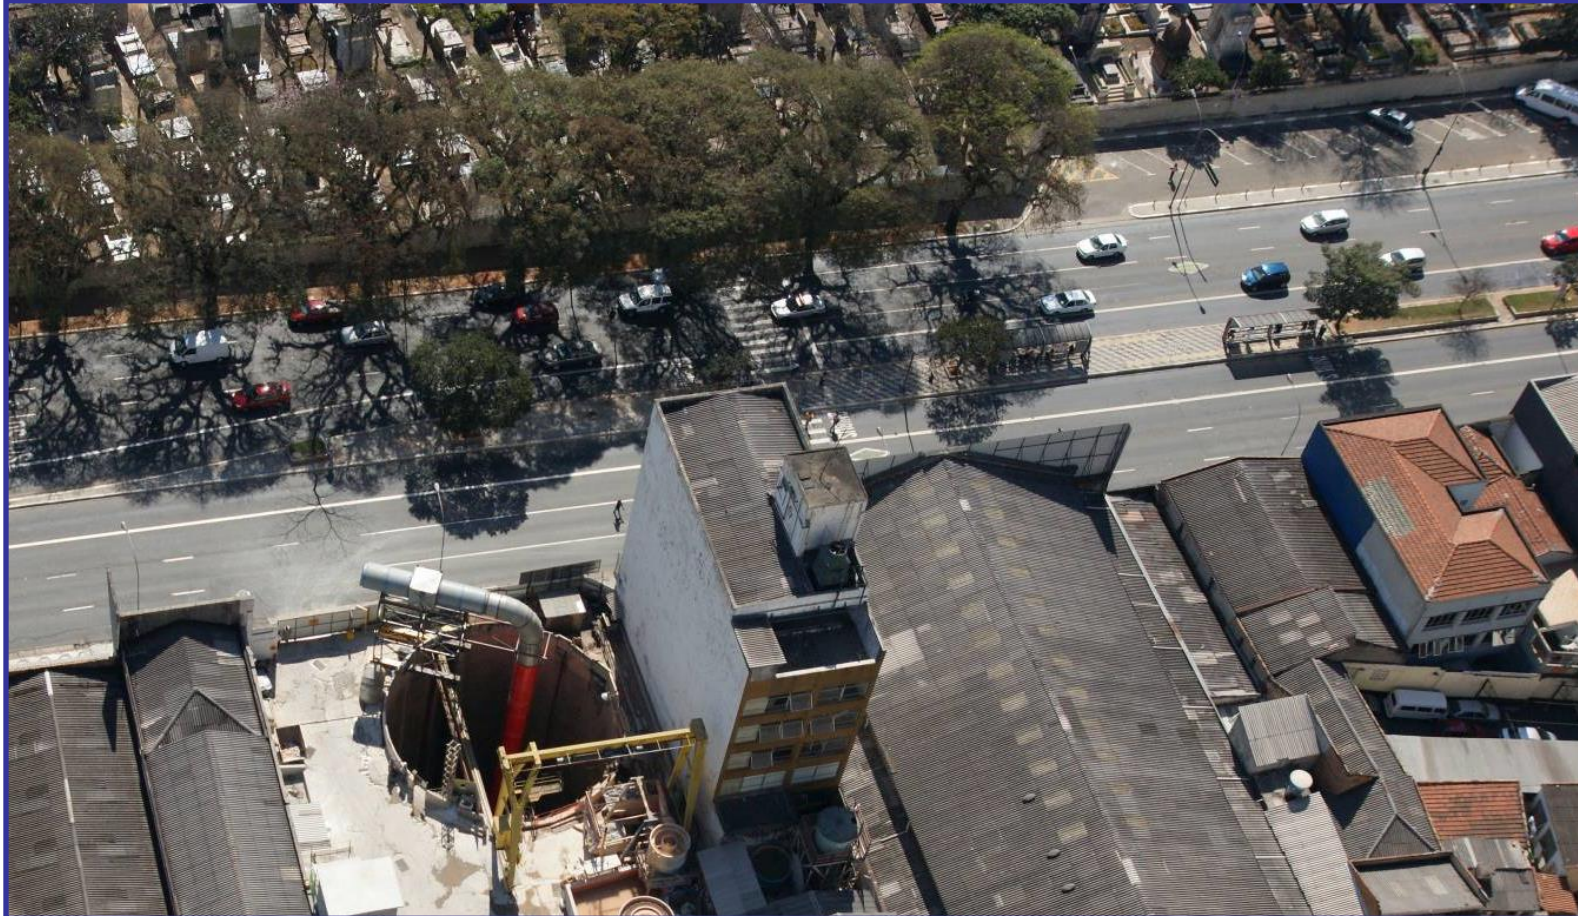
# Shotcrete Supported Shafts José Eusébio Shaft, São Paulo Line 4

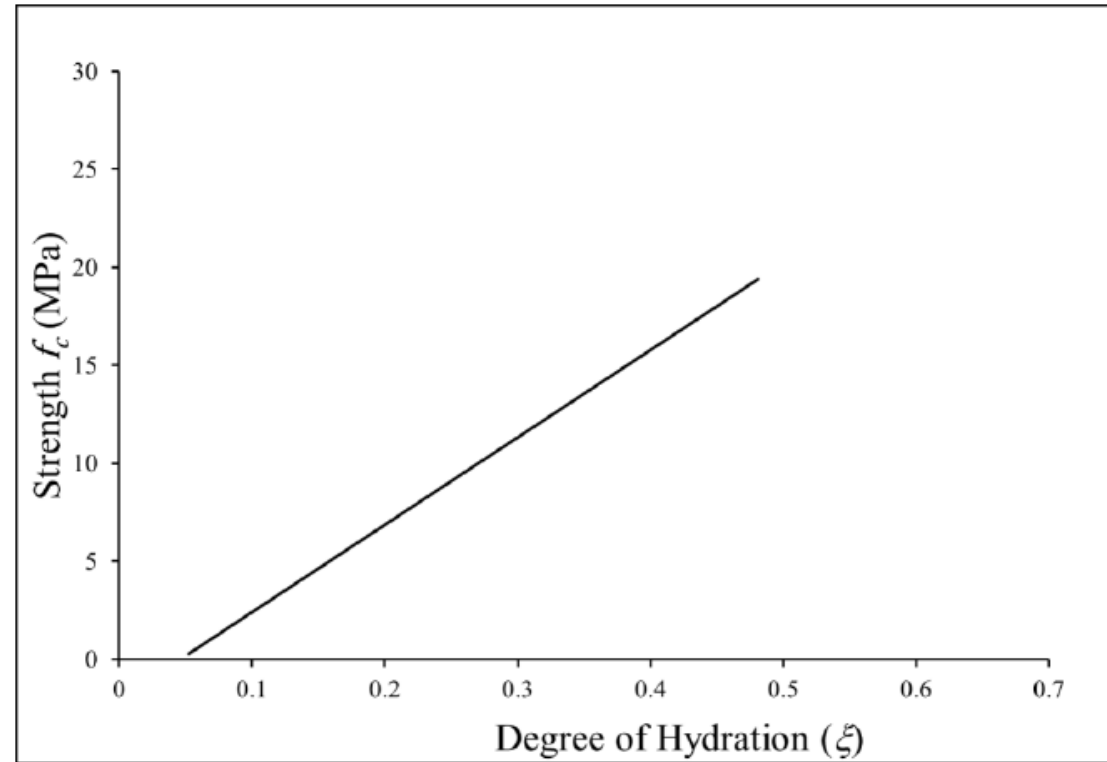
# SMUTI™ – evolution of strength with degree of hydration

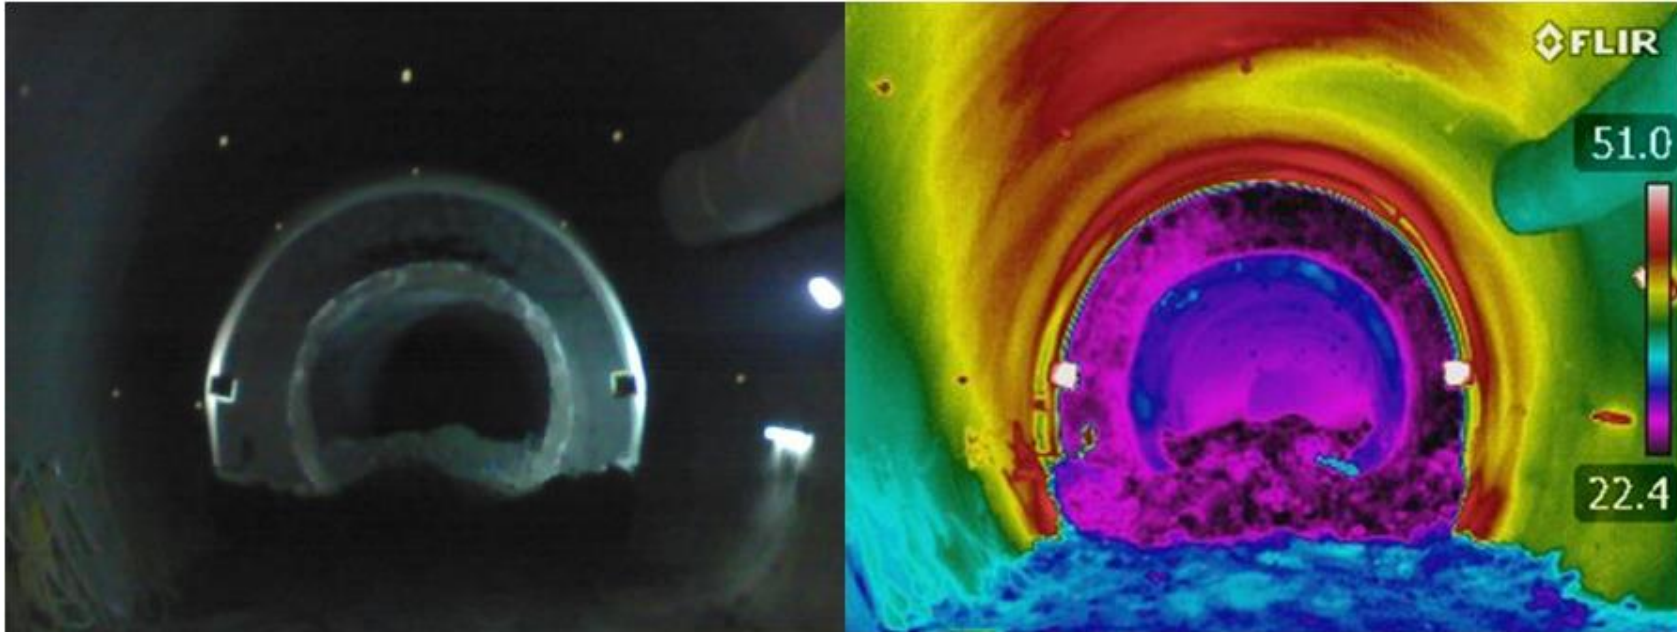
# Thermal scanning

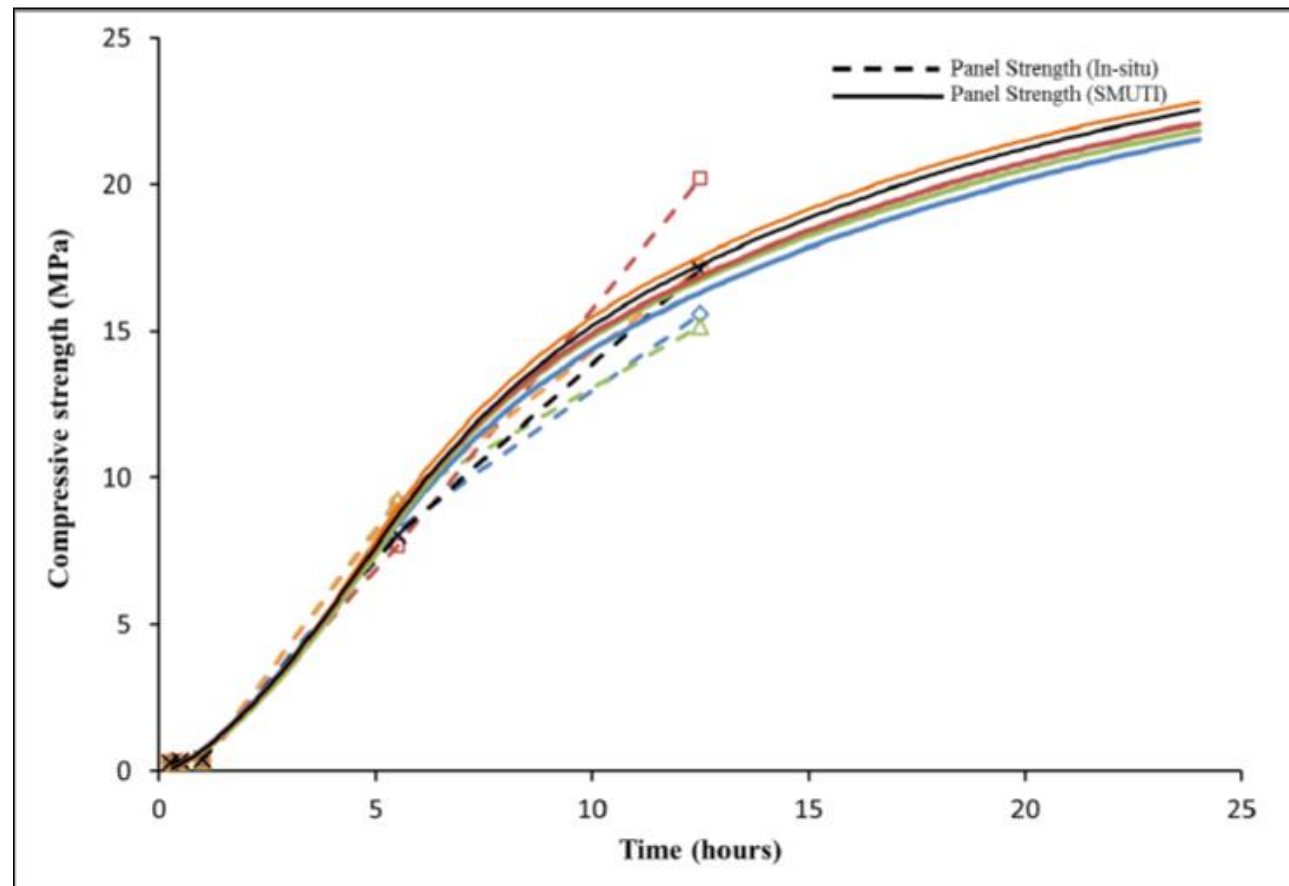
# Measured and evaluated compressive strengths

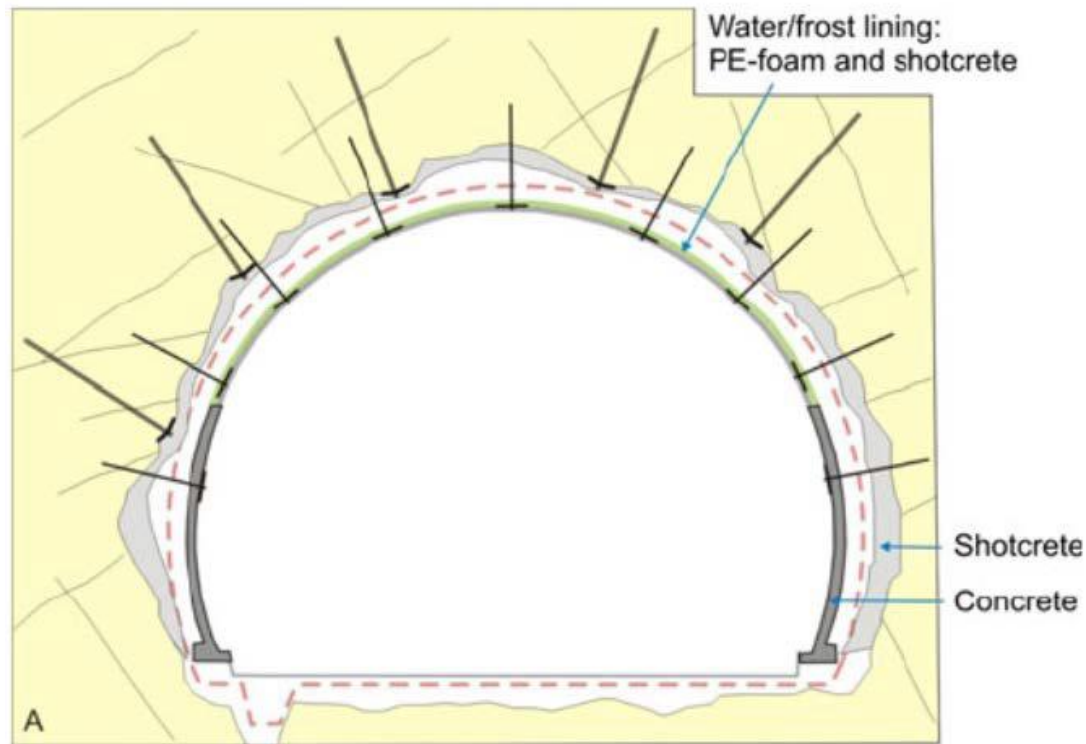
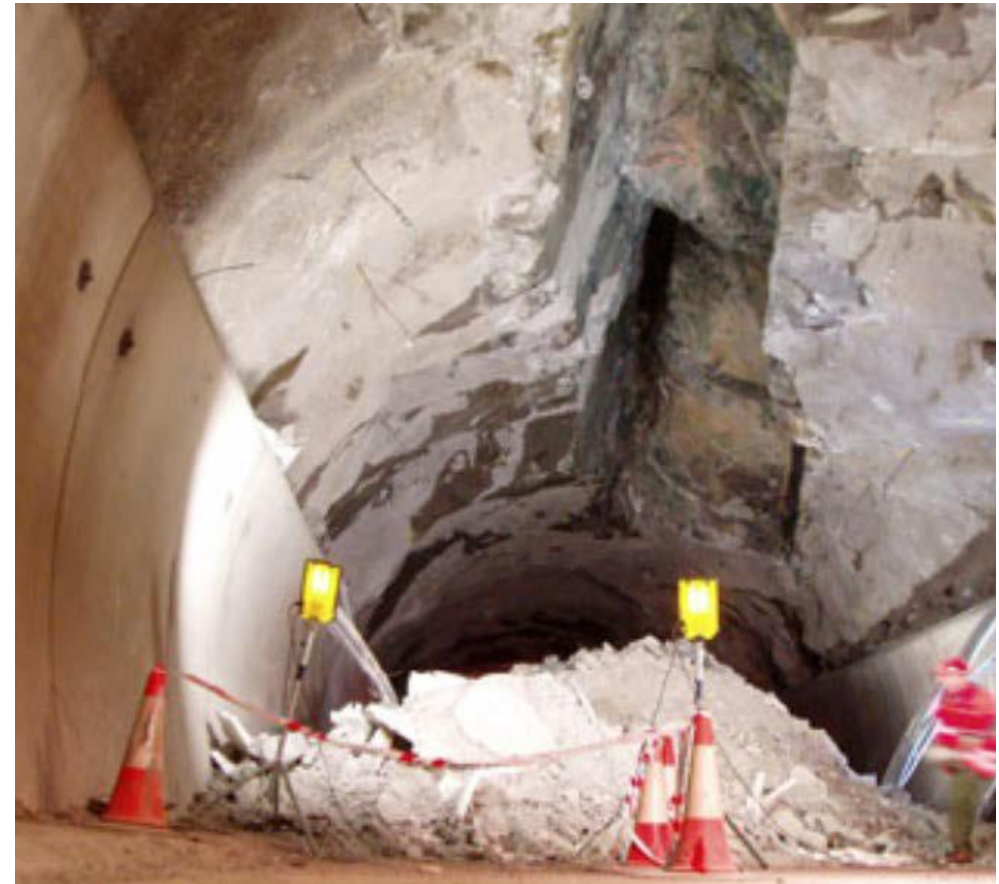
# Hanekleiv road tunnel, Norway

- Collapse 10 years after completion
- Fault zone in syenite
- $Q = 0.01 - 0.02$  (extremely poor)
- Fault gouge 5-10 cm thick, low content of swelling clay

- 15 cm of steel fiber reinforced sprayed concrete
- Cracks during construction
- Additional 10 cm sprayed concrete before cladding
- Collapse: 250 m<sup>3</sup>
- One large block (several tons); mainly small blocks, gravel and fragments of altered syenite
- Conclusion: insufficient support

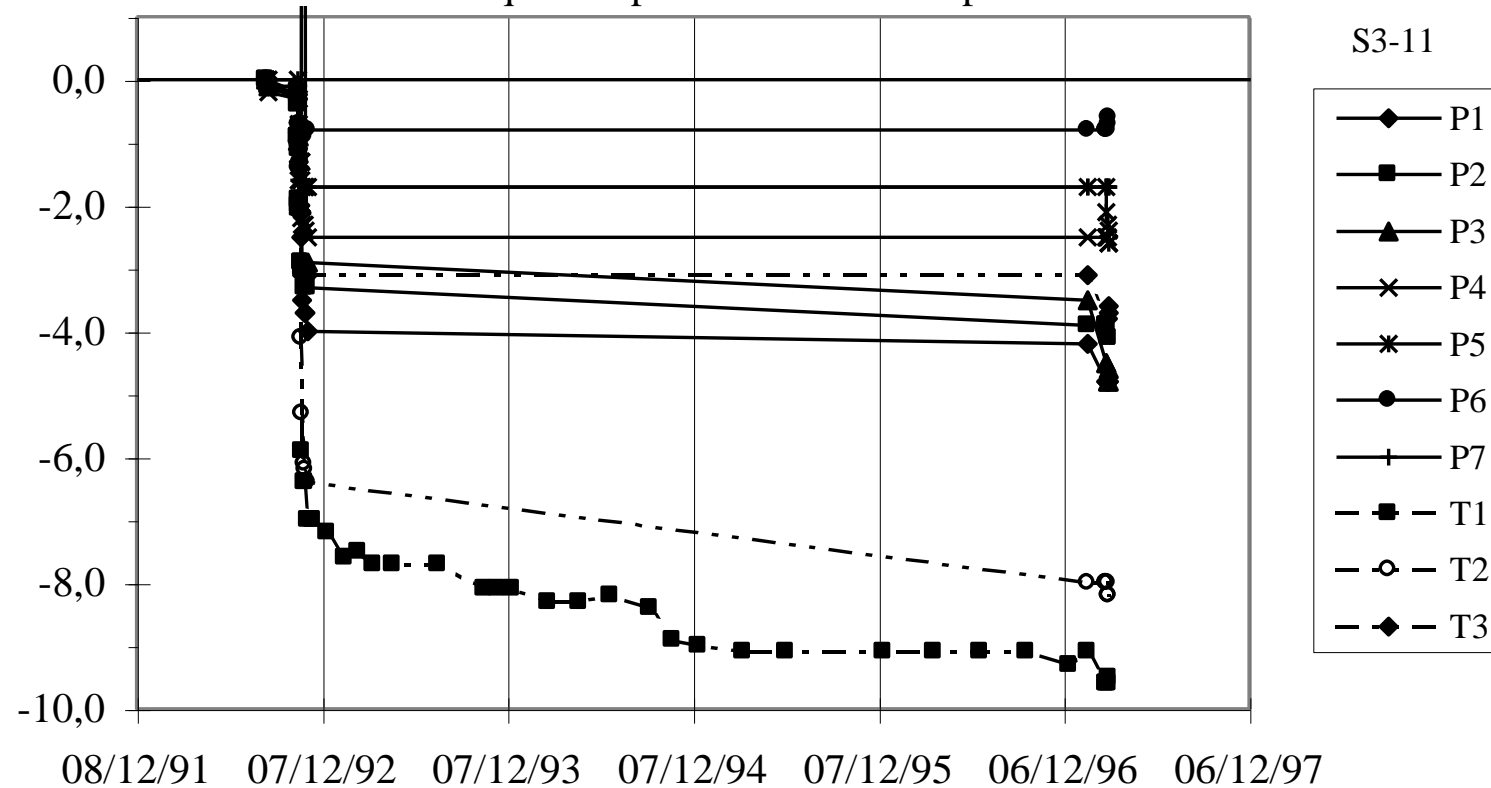
## Placas e Tassômetros - S3-11

Recalques de placa/tassom x Tempo

**Settlements along 4.5 years**  
**Jaciporã Tunnel, Line 2, São Paulo Metro**

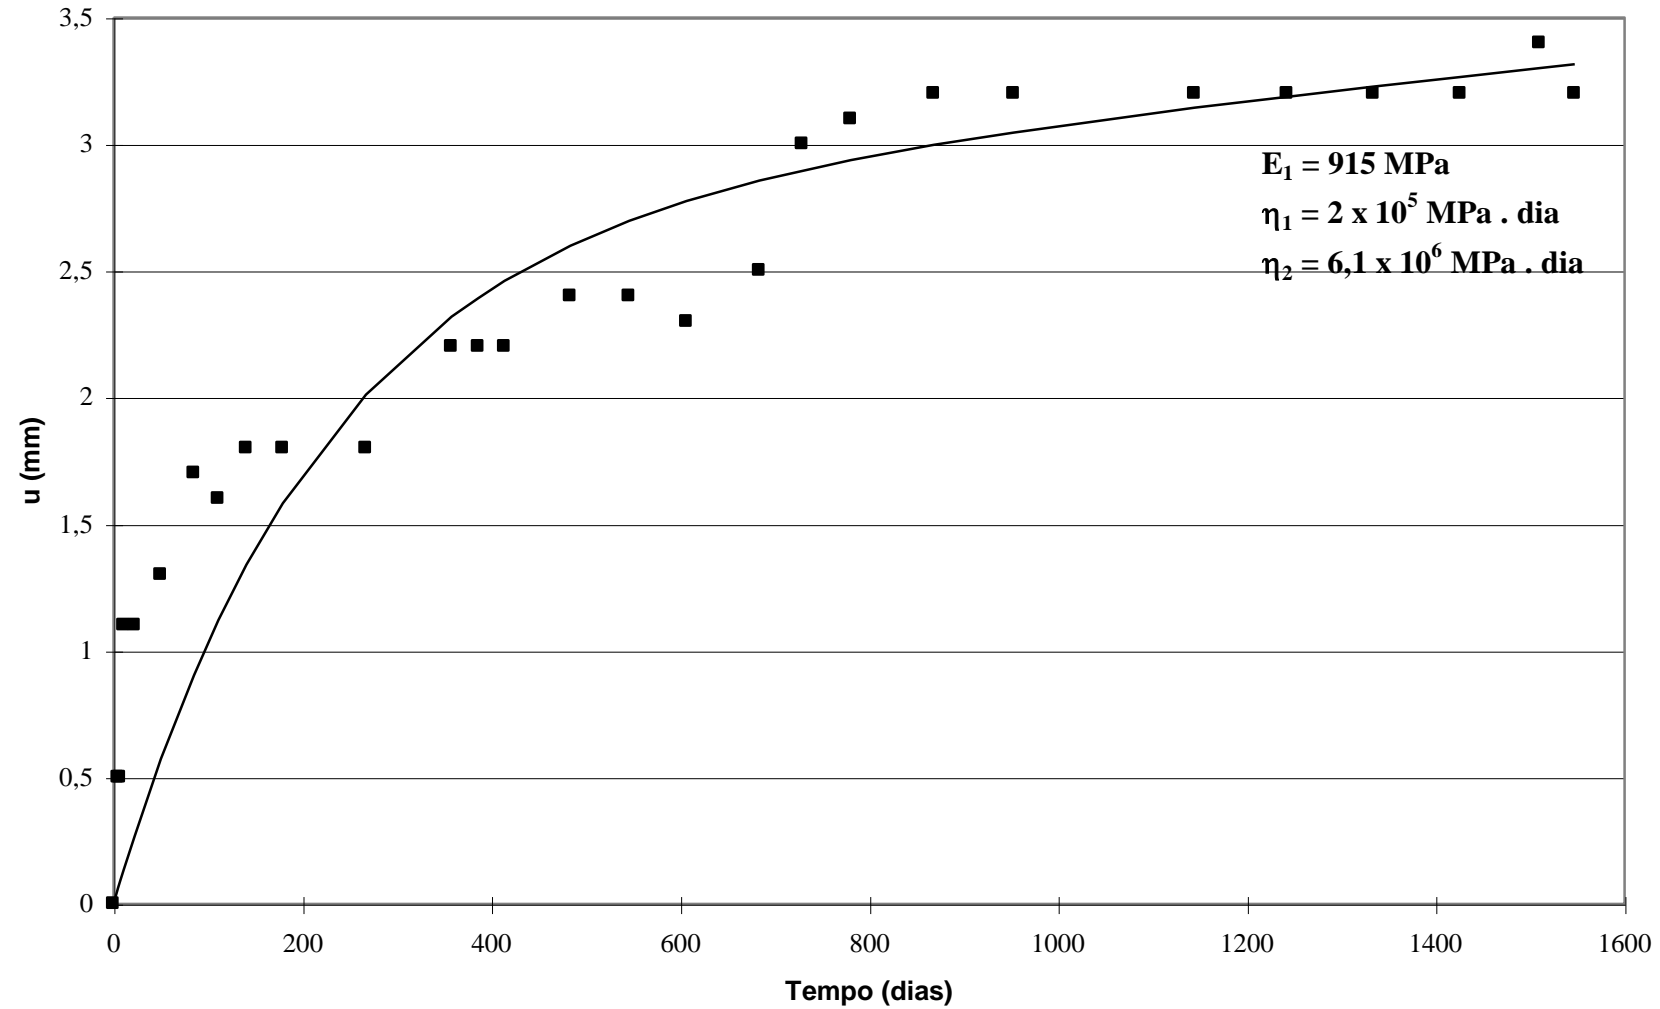
### Tassômetro T1 - Seção S3-11

## Curve fitting Burger's viscoelastic model

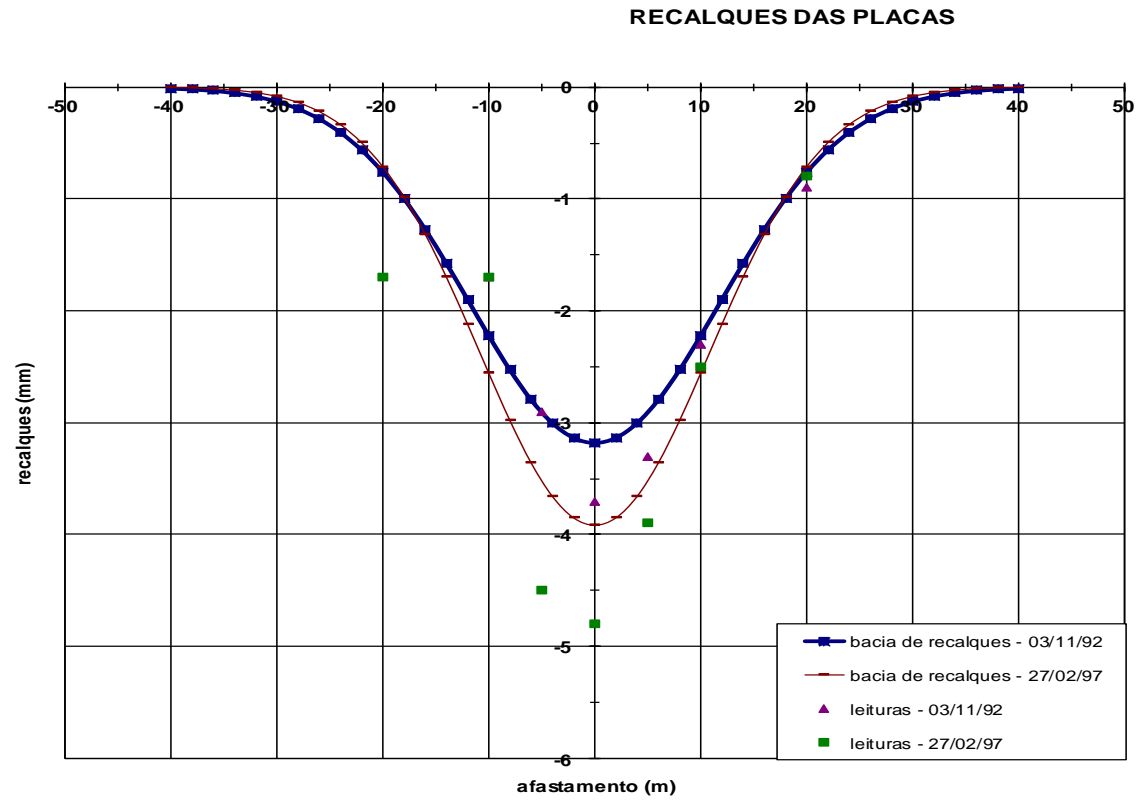
**Evolution of surface settlement trough**

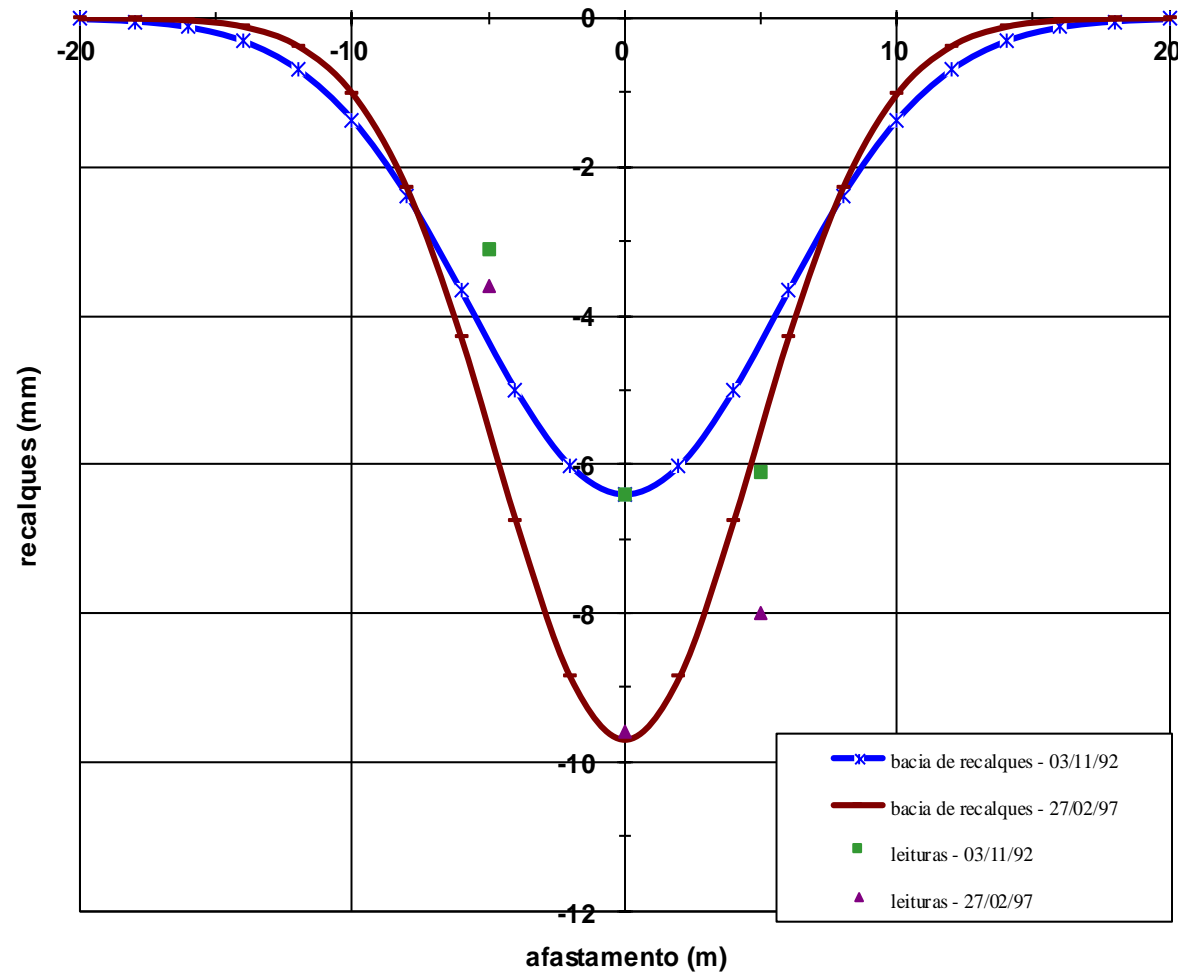
## RECALQUES DOS TASSÔMETROS

# Evolution of deep settlement trough
